**FIVE-YEAR REVIEW REPORT FOR
NL INDUSTRIES/TARACORP LEAD SMELTER SUPERFUND SITE
Granite City, IL**

**U.S. Environmental Protection Agency
Region 5
Chicago, IL**

3/28/2014

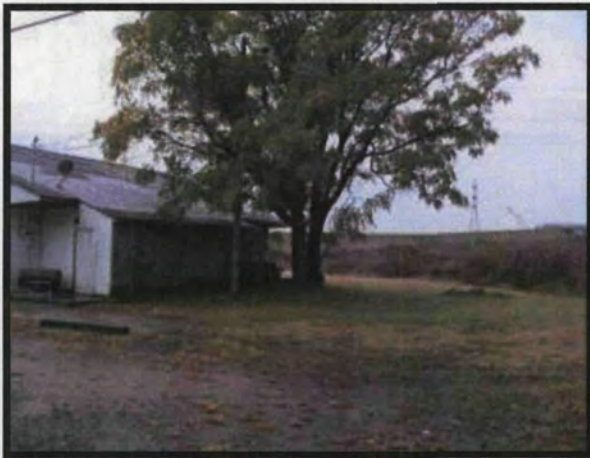
Photograph 3: Cleared area behind Robin's Nest Lounge.

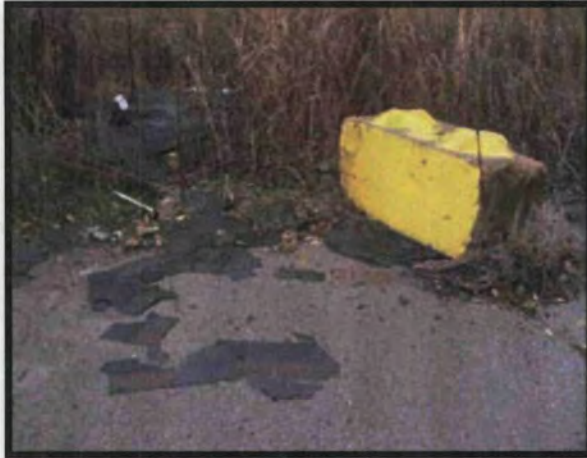
Photograph 7: Debris (roof shingles, wood, concrete) at Slough Road.

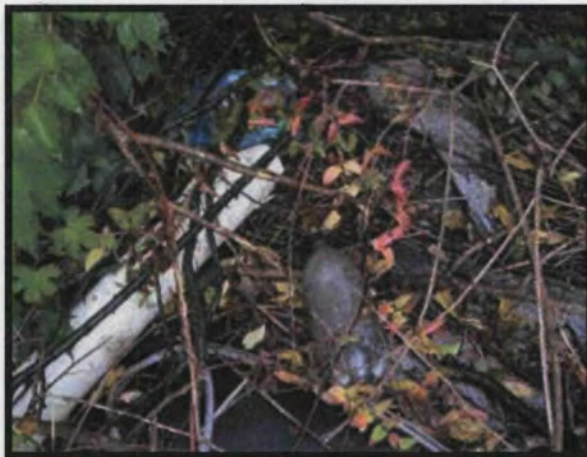
Photograph 9: Debris (PVC pipe, plastic, etc.) at Slough Road.

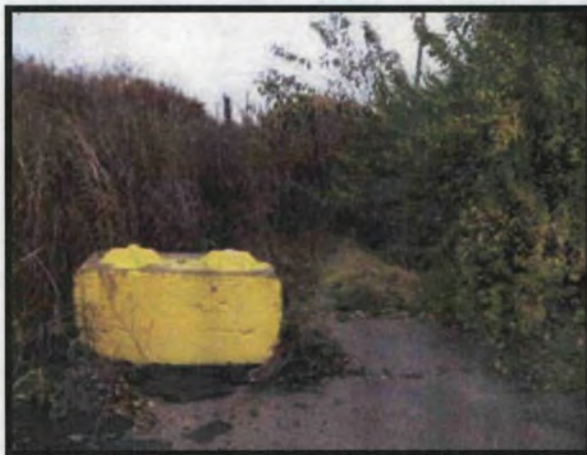
Photograph 11: Former paved area at Slough Road (now covered with about two feet of fill from Beelman operations and heavily vegetated).

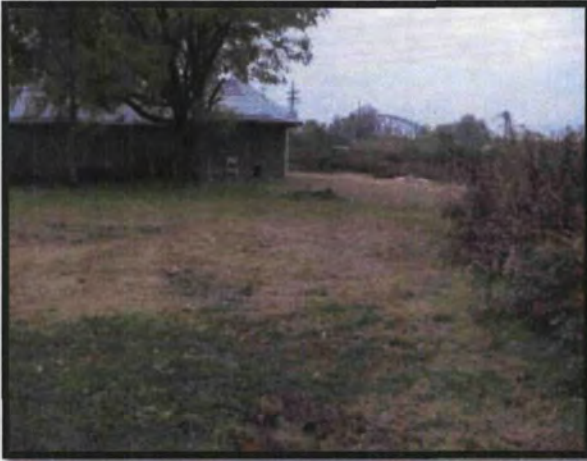
Photograph 13: Cleared area behind Robin's Nest Lounge.

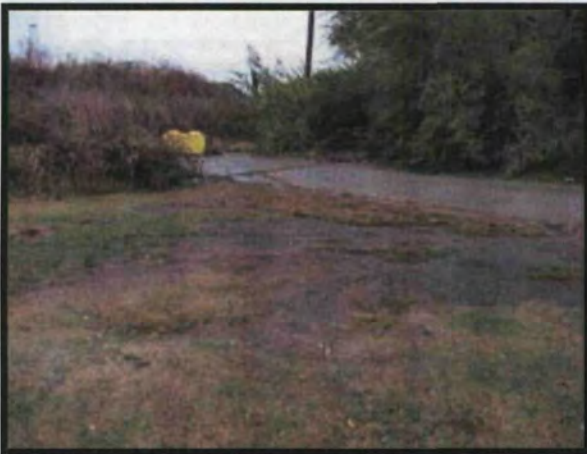
Photograph 17: Gravel area (scattered battery chips) adjacent to Slough Road.

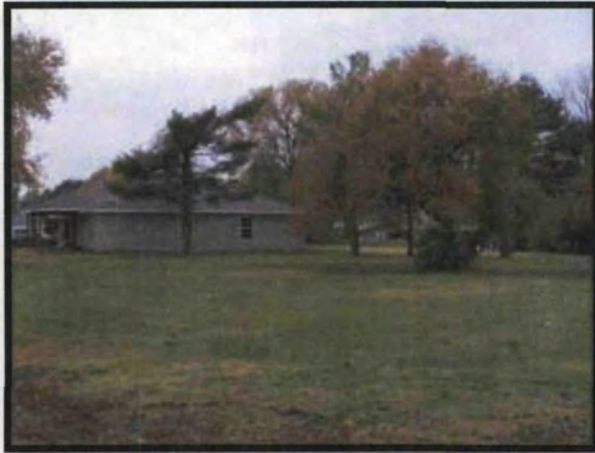
Photograph 7: Eagle Park Acres – former soil pile area 2 along Watson Street near Roosevelt Street (soil piles from ACOE sanitary sewer project have been removed and the property has been revegetated).

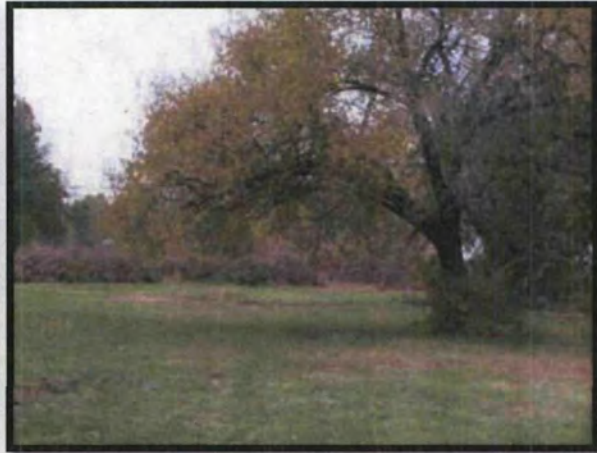
Photograph 8: Eagle Park Acres – former soil pile area 2 along Watson Street near Roosevelt Street (soil piles from ACOE sanitary sewer project have been removed and the property has been revegetated).

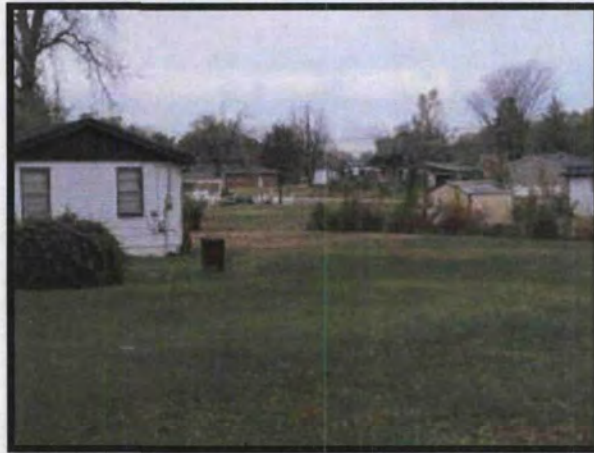
Photograph 9: Eagle Park Acres – former soil pile area 1 along Hare Street (soil piles from ACOE sanitary sewer project have been removed and the property has been revegetated).

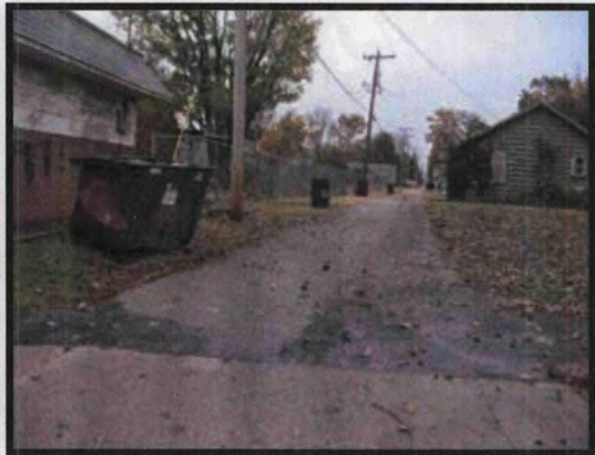
Photograph 12: Alley between Market Street and Logan Street (view east from Baucum Street).

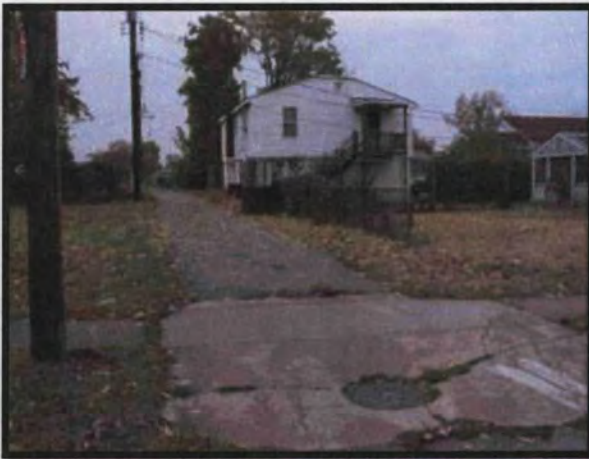
Photograph 13: Alley between Bissell Street and Market Street (view west from Meredocia Street).

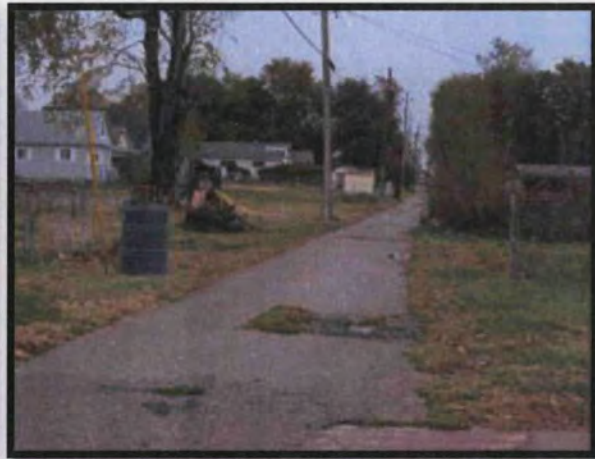
Photograph 14: Alley between Market Street and Logan Street (view east from Meredocia Street).

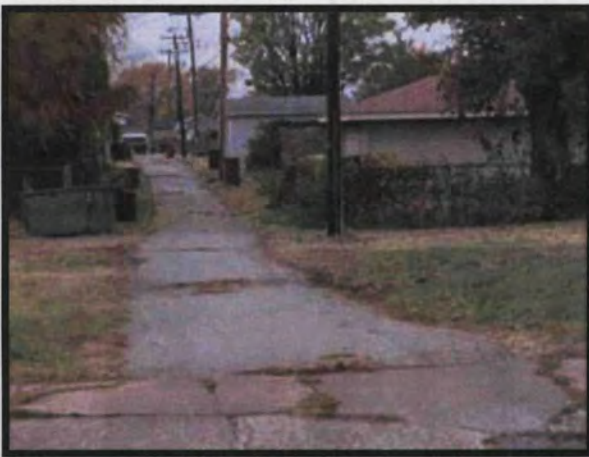
Photograph 15: Alley between Market Street and Logan Street (view west from Meredocia Street).

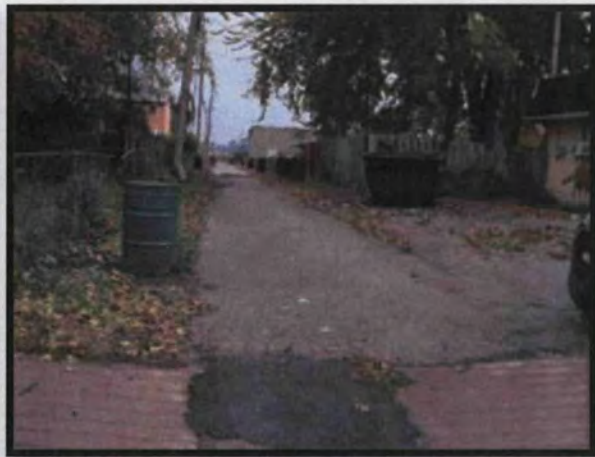
Photograph 16: Alley between Market Street and Logan Street (view east from Selb Street).

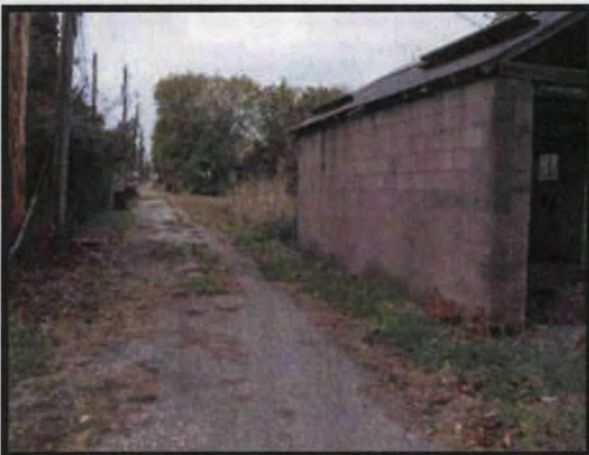
Photograph 17: Alley between Calhoun Street and Douglas Street (view west from Line Alley). Several holes have been filled with asphalt since June 2012 inspection.

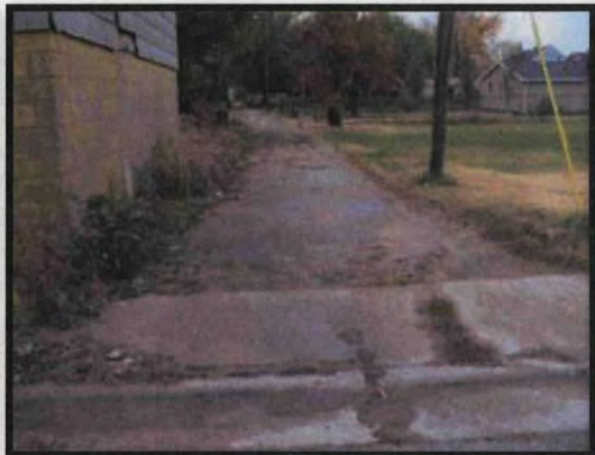
Photograph 18: Alley between Salveter Street and Meredocia Street (view south from Rogan Street).

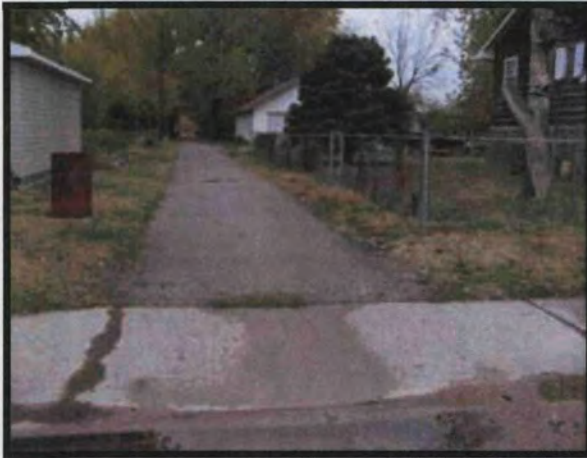
Photograph 19: Alley between Allen Street and Rogan Street (view north from Allen Street).

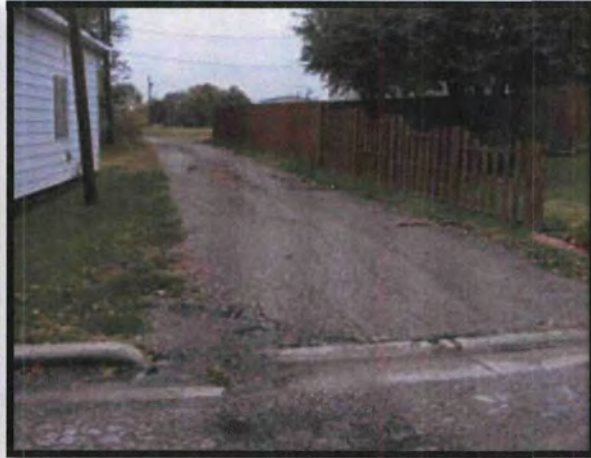
Photograph 20: Alley between Baucum Street and West 3rd Street (view south from Madison Street and College Street).

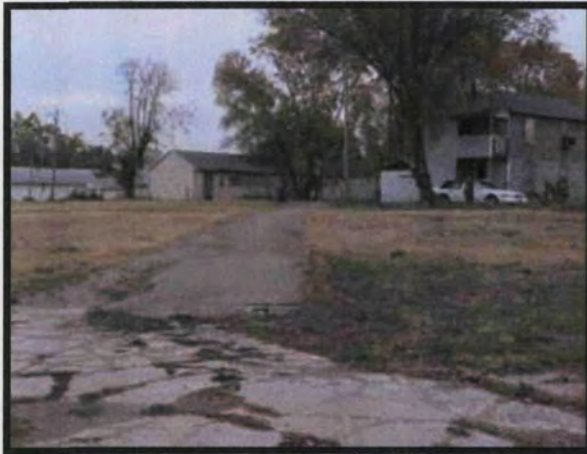
Photograph 21: Alley on Jackson Street (between 3rd Street and Baucum Street).

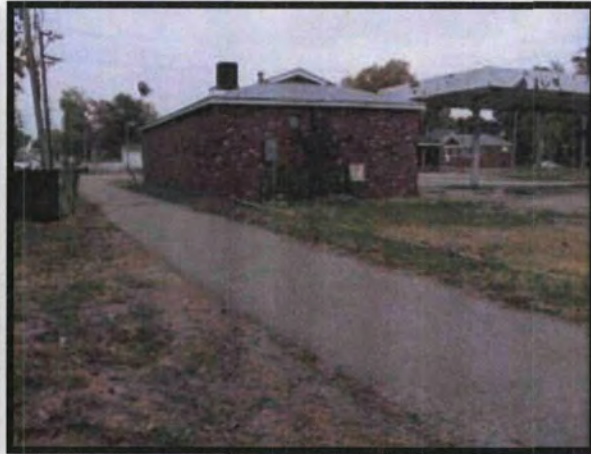
Photograph 22: Alley between 4th Street, Broadway, and Lincoln Avenue.

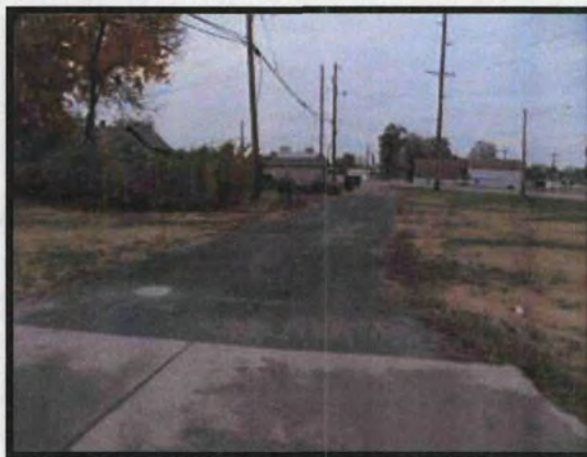
Photograph 23: Alley between 3rd Street and 4th Street (view north from Abbott Street).

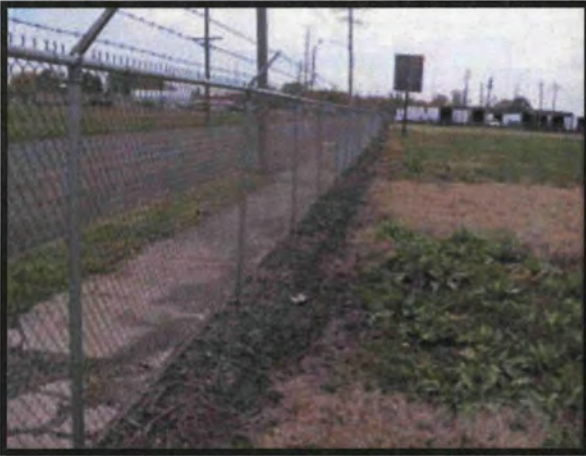
Photograph 1: Vegetation inside fence (view southwest along State Street).

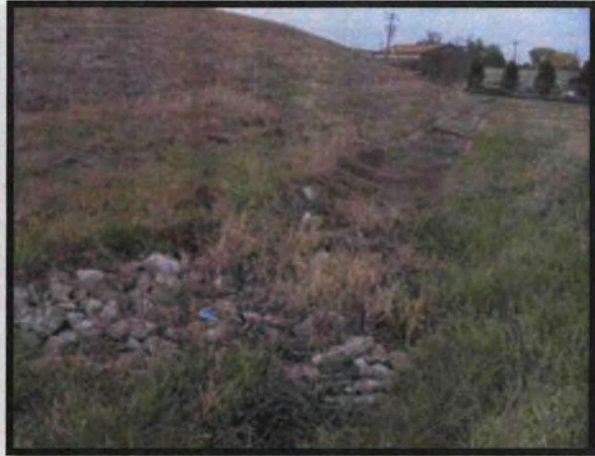
Photograph 2: Concrete drainage swale, south side of Taracorp pile (view northeast).

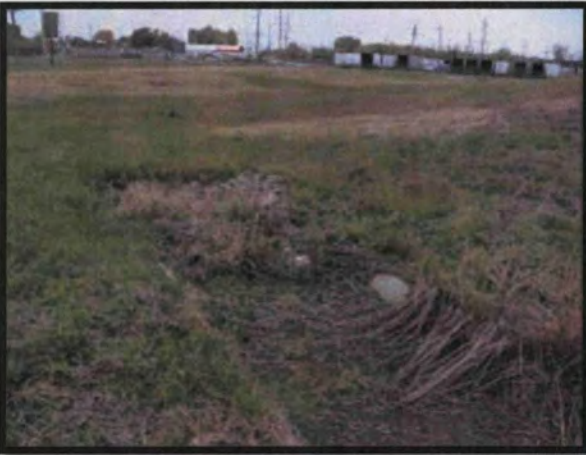
Photograph 3: End of concrete drainage swale, south side of Taracorp pile.

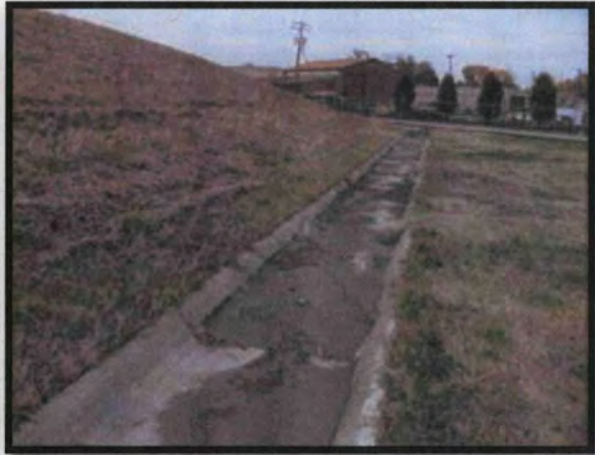
Photograph 4: Concrete drainage swale, south side of Taracorp pile (view northeast).

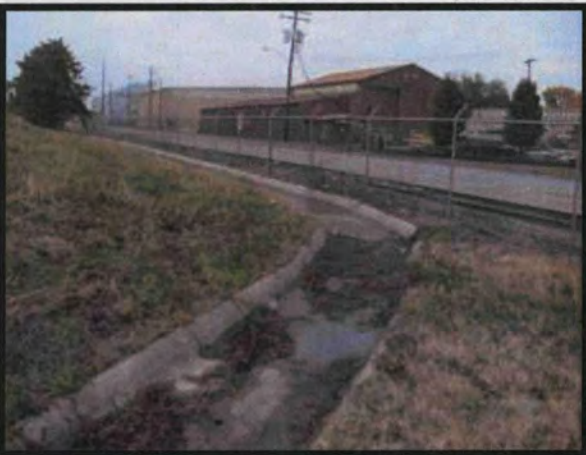
Photograph 5: Concrete drainage swale, east side of Taracorp pile (view northeast).

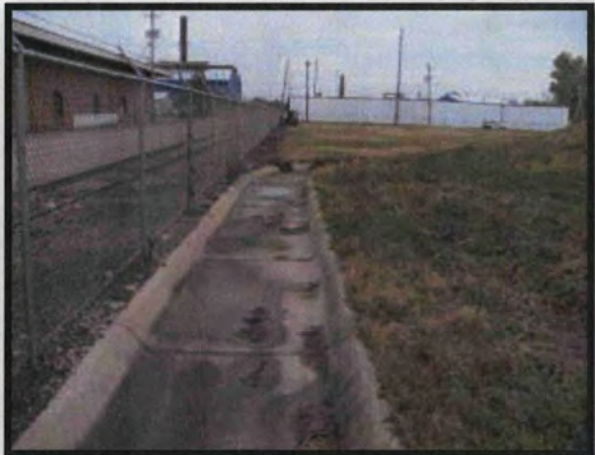
Photograph 6: Concrete drainage swale, east side of Taracorp pile (view southeast).

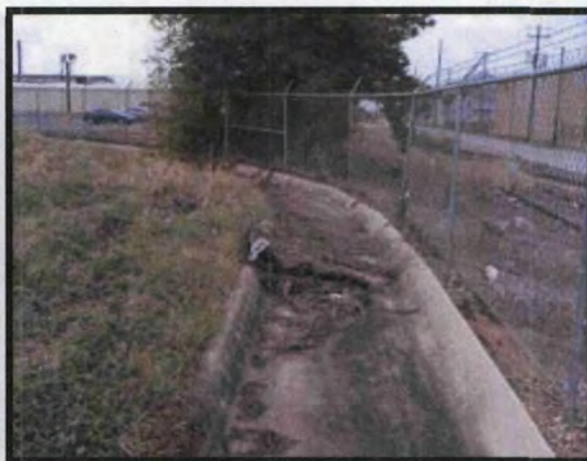
Photograph 7 and Photograph 8: Concrete drainage swale, fence, and vegetation, northeast side of Taracorp pile along 16th Street (view northwest).

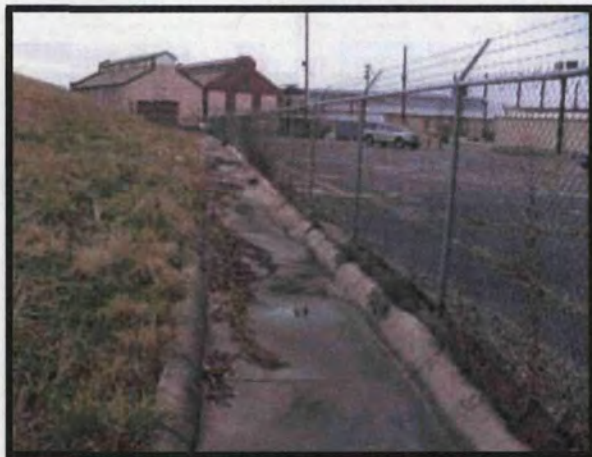
Photograph 9: Concrete drainage swale and vegetation, northwest side of Taracorp pile (view southwest).

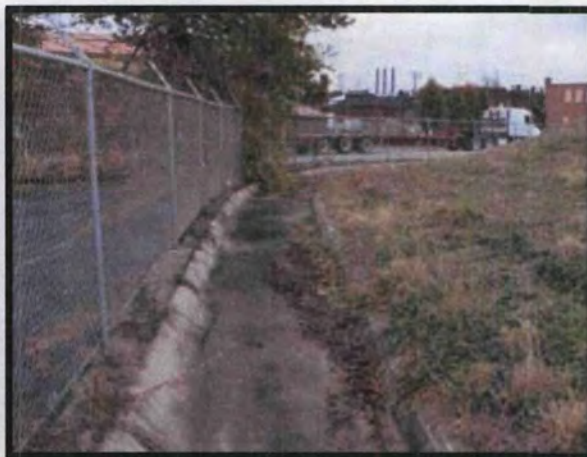
Photograph 10: Concrete drainage swale, northwestern side of Taracorp pile (view northeast).

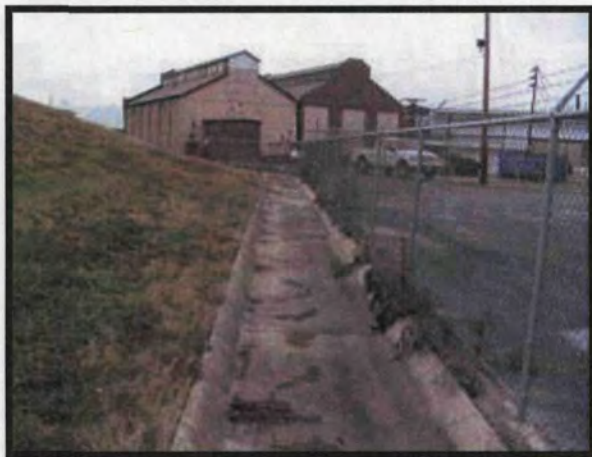
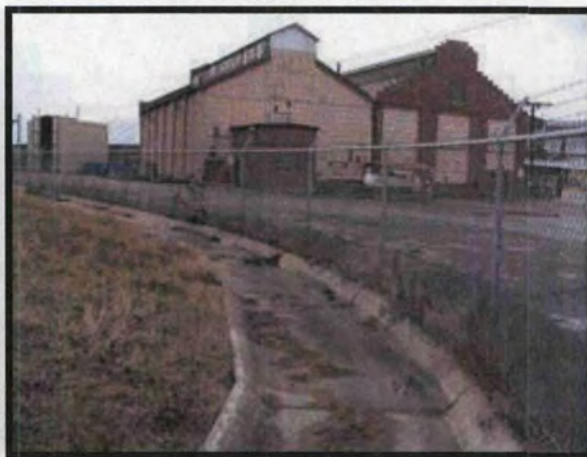
Photograph 11 and Photograph 12: Concrete drainage swale, fence, and vegetation along northwestern side of Taracorp pile (view southwest).

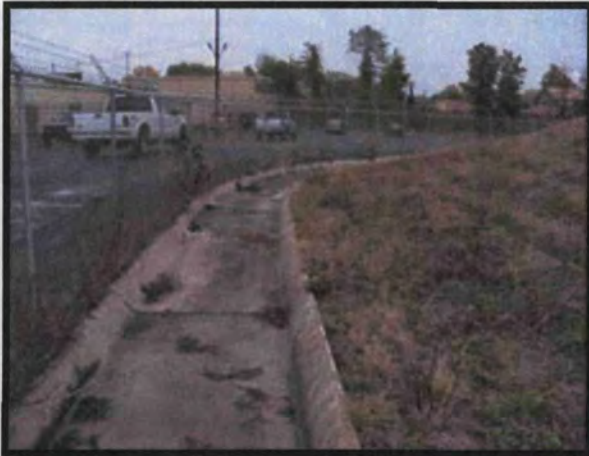
Photograph 13: Concrete drainage swale, vegetation along northwestern side of Taracorp pile (view north/northeast).

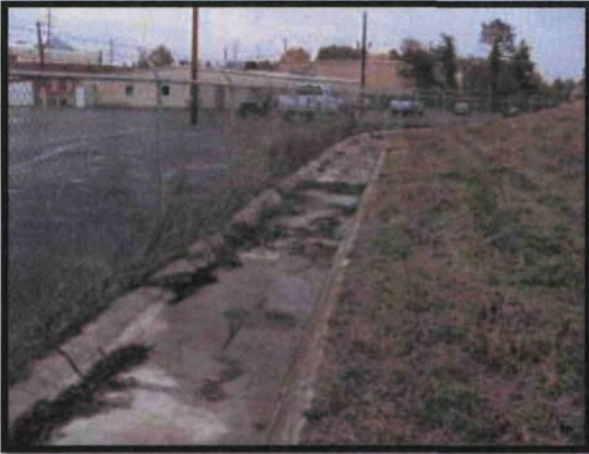
Photograph 15: Vegetation near base of west side of Taracorp pile (view northeast).

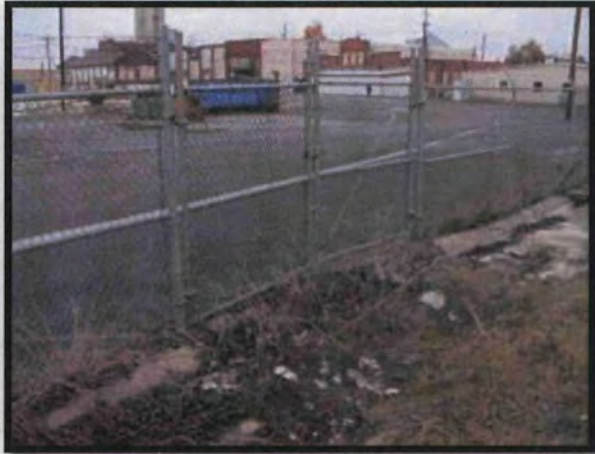
Photograph 16: Vegetation near base of northwest side of Taracorp pile (view northwest).

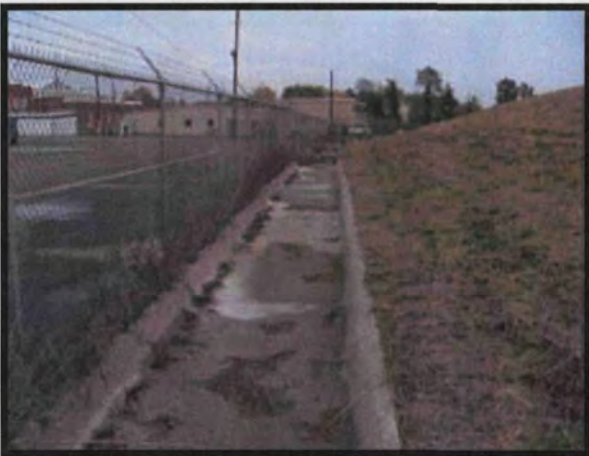
Photograph 17: Vegetation near base of western side of Taracorp pile (view north).

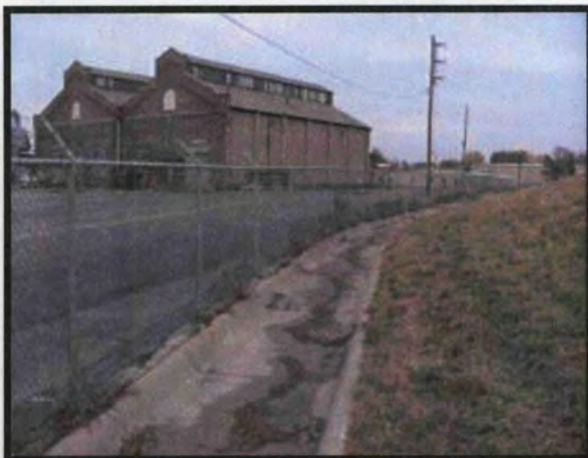
Photograph 19: Vegetation along western side of Taracorp pile cap (view north).

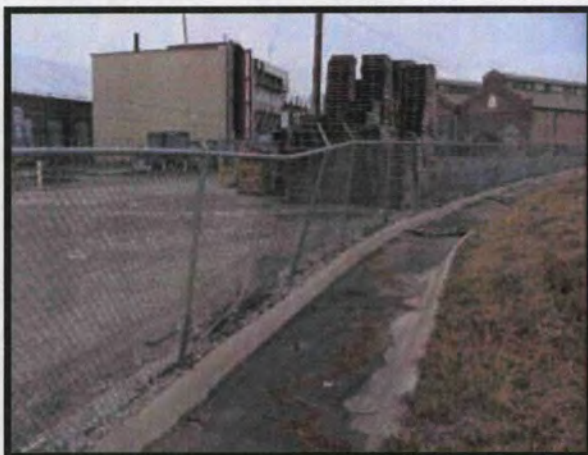
Site Structure	Inspected (yes/no)	Inspection Observations	Maintenance Work Performed or Required
Security Fence:			
Gates/locks secure and operative	Yes	Gate near 16th and State Streets was locked at the time of the inspection. The NL Industries/Taracorp Superfund Site Group's combination lock and the combination lock that Munie Greencare Professionals (Munie) installed on the front gate in August 2007 were in operational condition. No evidence of rust/corrosion was observed.	
Evidence of rust, cuts, deterioration	Yes	The fence was secure; no evidence of excessive rust, cuts, or significant deterioration.	
Evidence of unauthorized entry	Yes	No evidence of unauthorized entry.	
Burrowing or tunneling under fence	Yes	No evidence of burrowing or tunneling under fence.	
Damaged barbed wire	Yes	No evidence of damaged barbed wire.	
Comments		A small section of fence (Attachment 4, photographs 20 and 21) on the western side of the Taracorp pile was observed to be slightly bent, and a small section of barbed wire at the top of the fence was broken.	Although a small section of fence is slightly bent, the fence is still intact and acceptable for restricting access. Continue to monitor.

Photograph 21: Bent fence posts along western side of Taracorp pile cap.

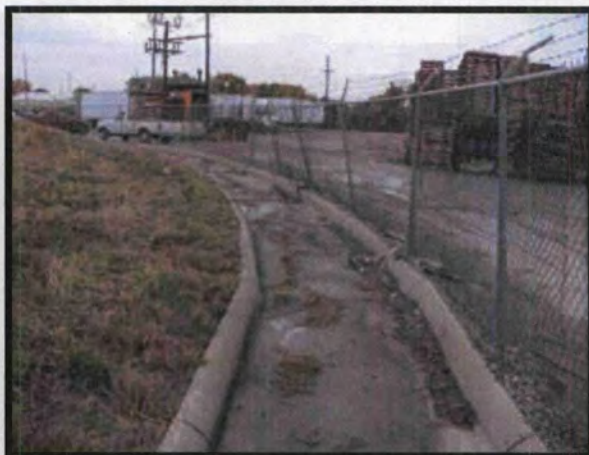
Photograph 22: Vegetation/concrete drainage swale, southwestern side of Taracorp pile cap (view southeast).

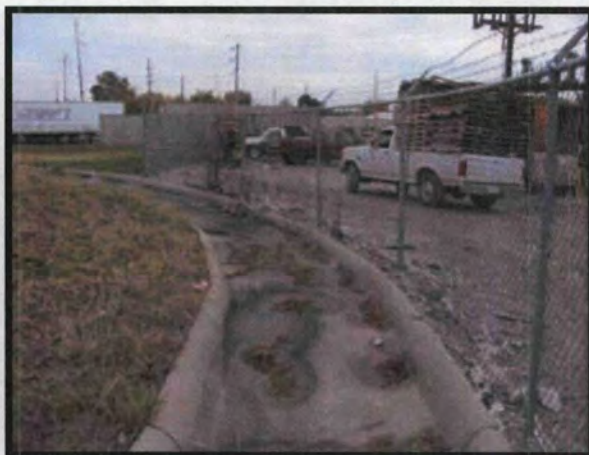
Photograph 24: Concrete drainage swale/fence along southwestern slope of Taracorp pile cap (view southeast).

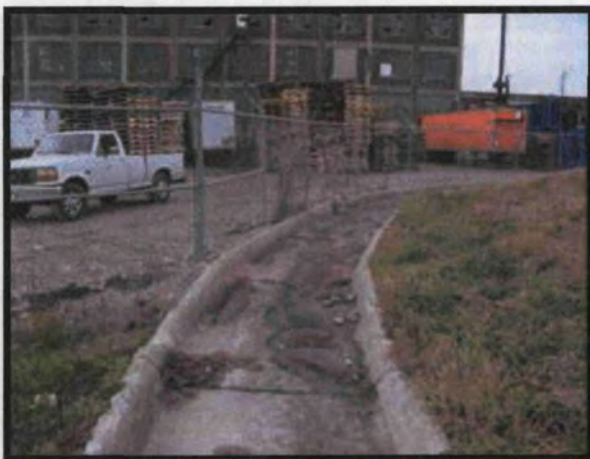
Photograph 25: Vegetation/concrete drainage swale along southwestern slope of Taracorp cap pile (view west).

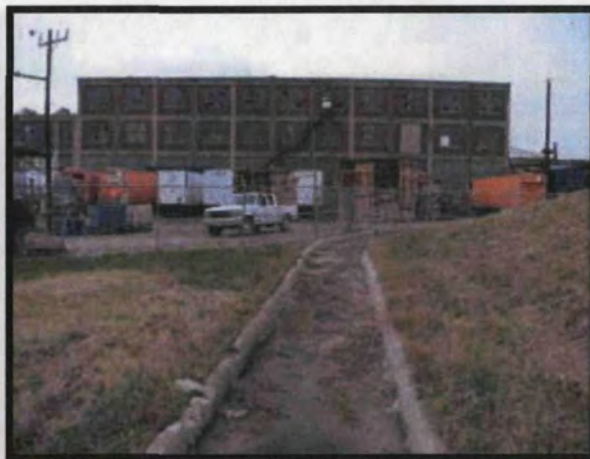
Photograph 26: Vegetation/concrete drainage swale along southwestern slope of Taracorp cap pile (view west).

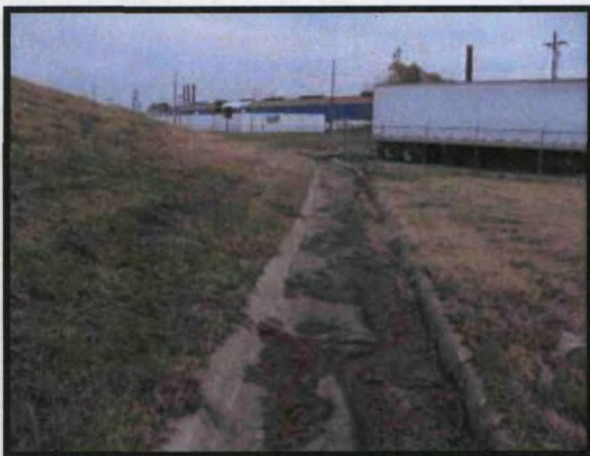
Photograph 27: Concrete drainage swale along southern slope of Taracorp pile.

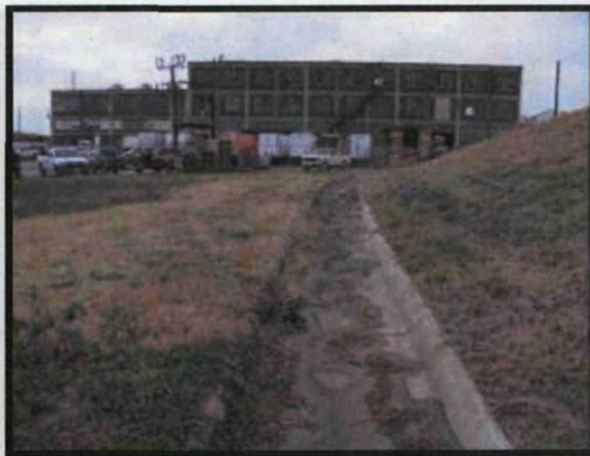
Photograph 28: Concrete drainage swale along southern slope of Taracorp pile.

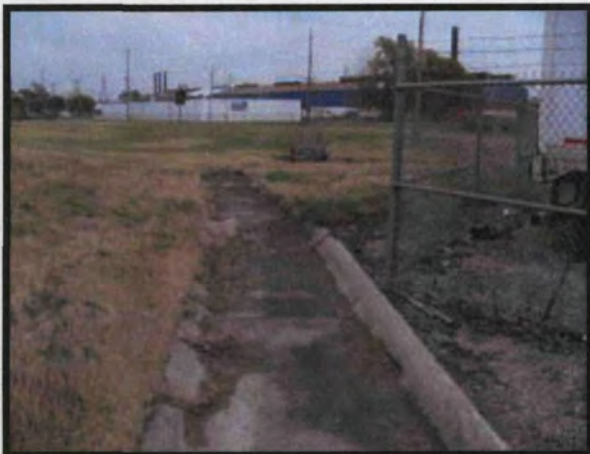
Photograph 29: Concrete drainage swale along southern slope of Taracorp pile.

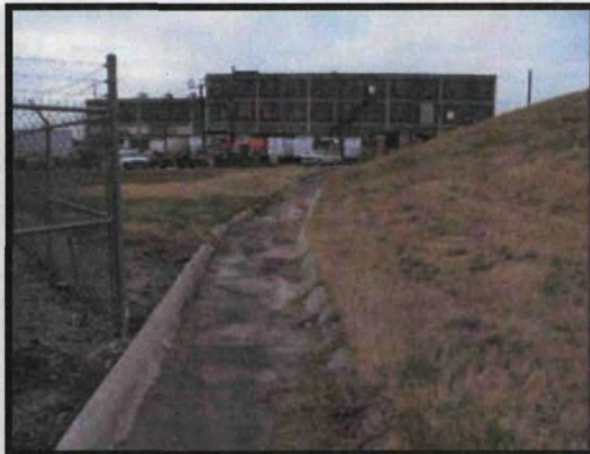
Photograph 30: Concrete drainage swale along southern side of Taracorp pile.

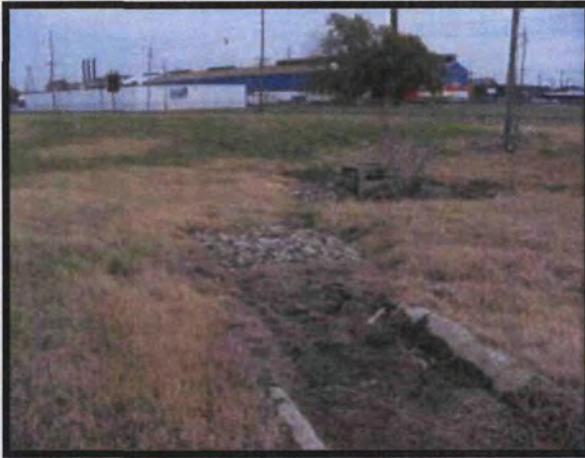
Photograph 31: Vegetation along southeast side of Taracorp pile cap (view northeast).

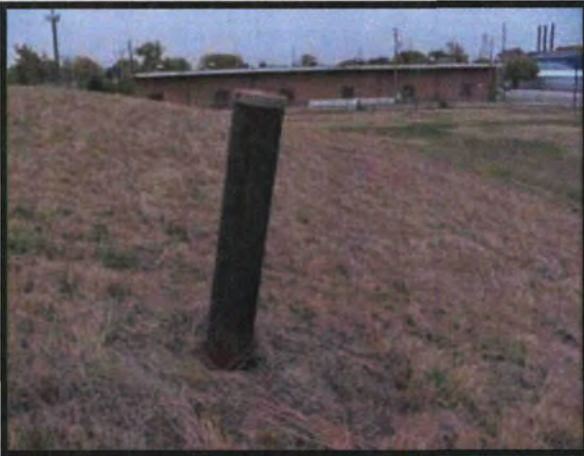
Photograph 42: Leachate riser pipe.

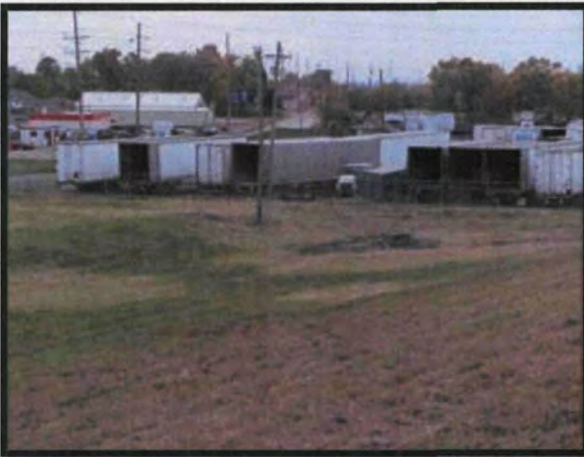
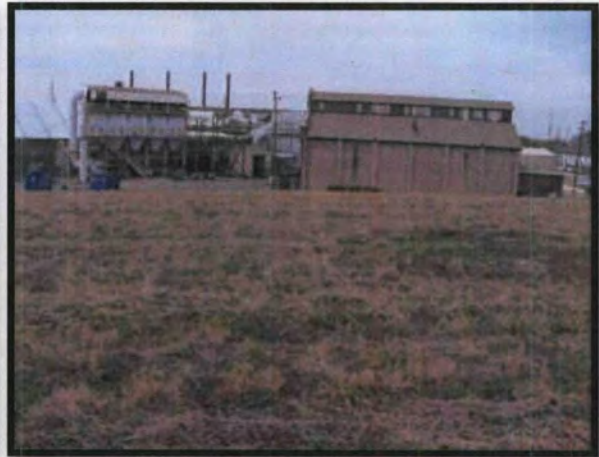
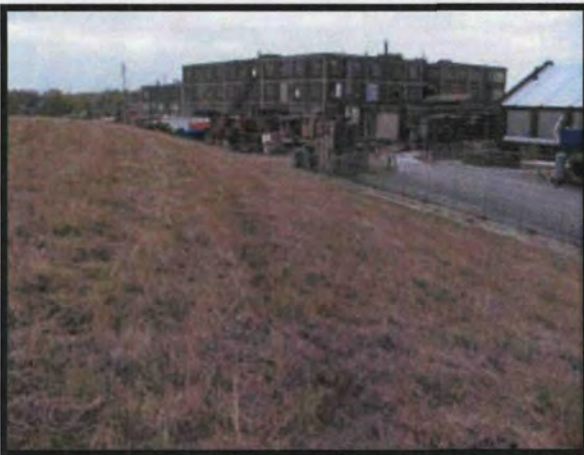
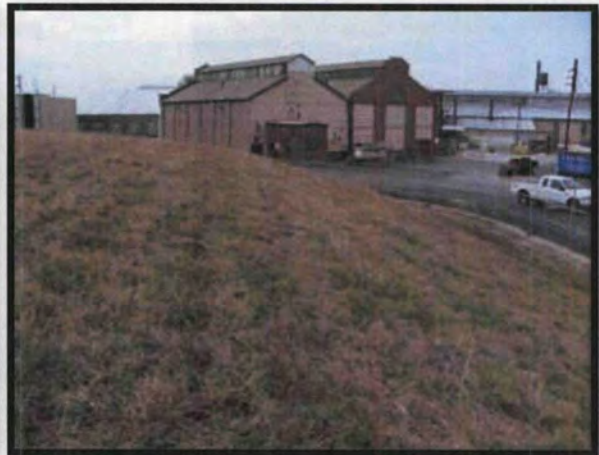
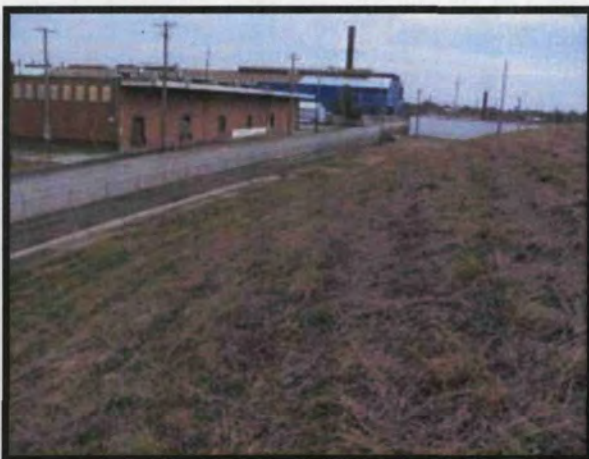
4. Photographs showing the Taracorp pile cap and main industrial site are provided in Attachment 4. Vegetation is thick and abundant on the cap; no significant problems related to the perimeter security fence and locked gate were observed.

Photograph 44: Former Rich Oil facility (view south from southern side of Taracorp pile cap).

Photograph 45: Vegetation on central top portion of Taracorp pile cap.

Photograph 46: Vegetation on western side of Taracorp pile cap.

Photograph 47: Vegetation on slope on western side of Taracorp pile cap.

Photograph 48: Vegetation on northern slope of Taracorp pile cap.

Photograph 50: Vegetation on northeastern side of Taracorp pile cap.

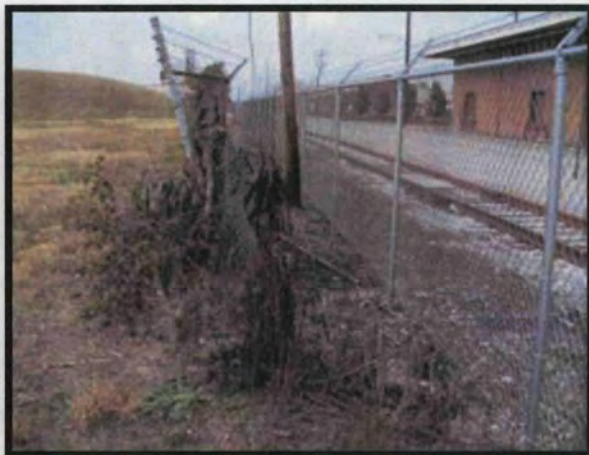
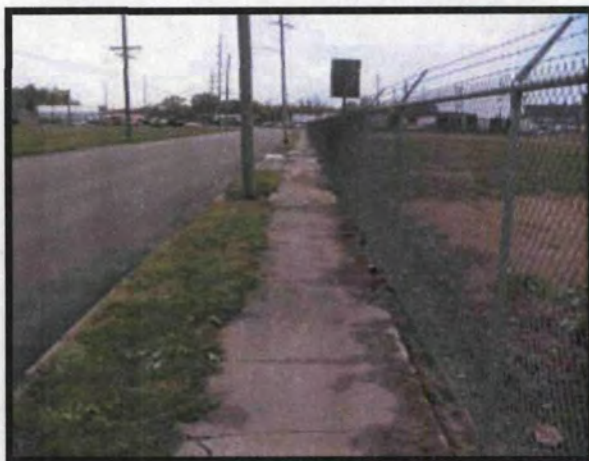
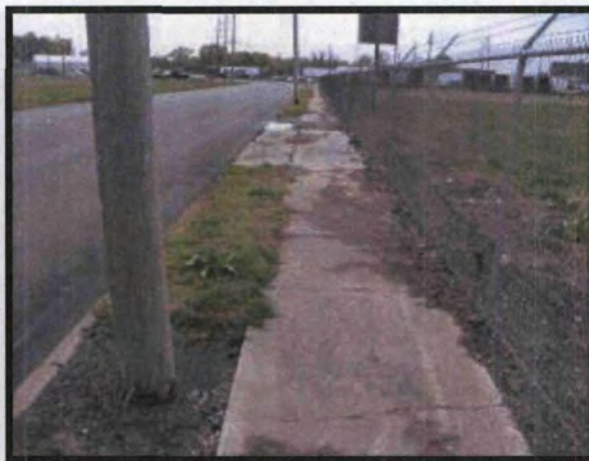
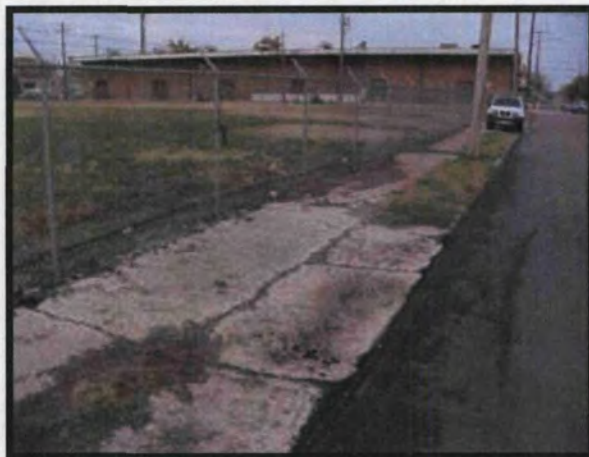
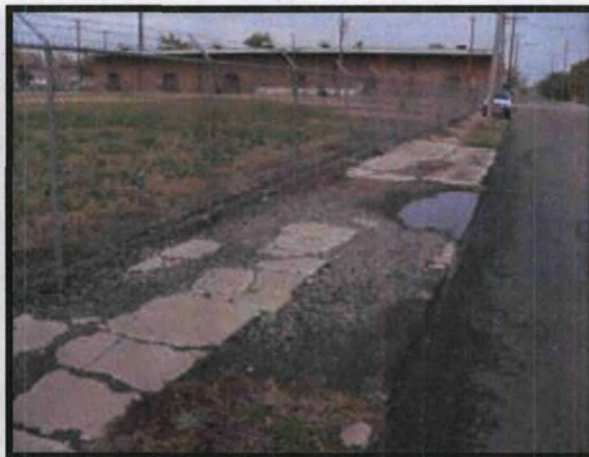
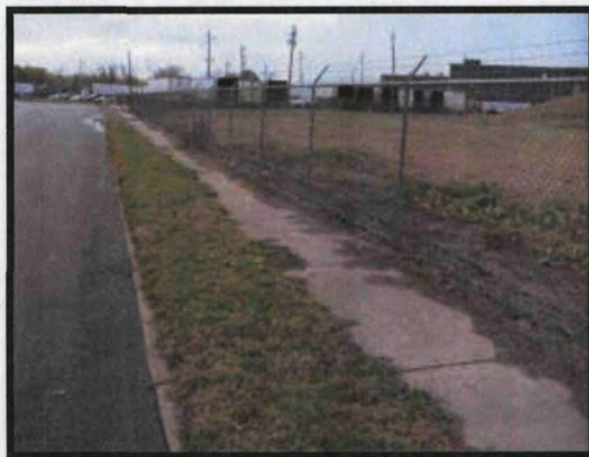
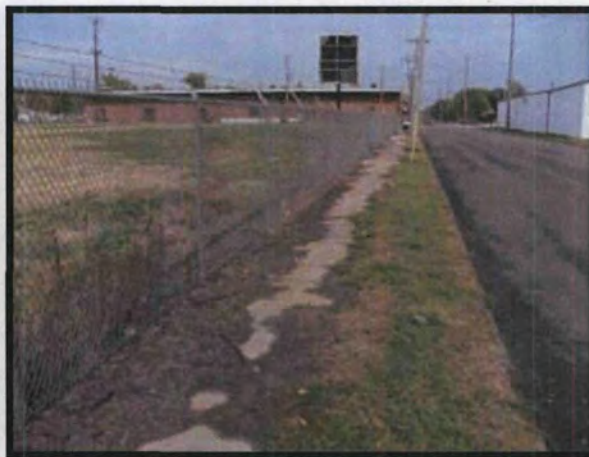
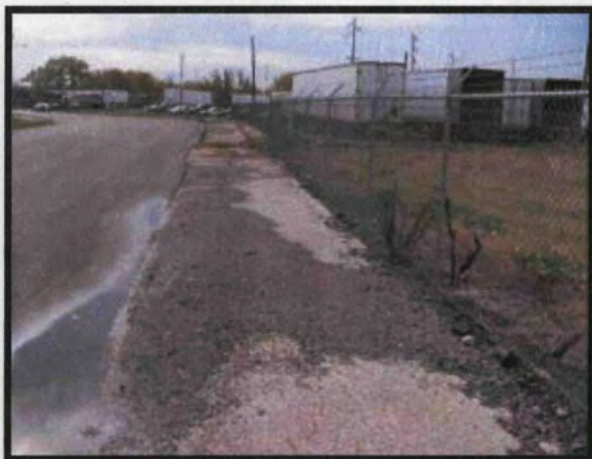
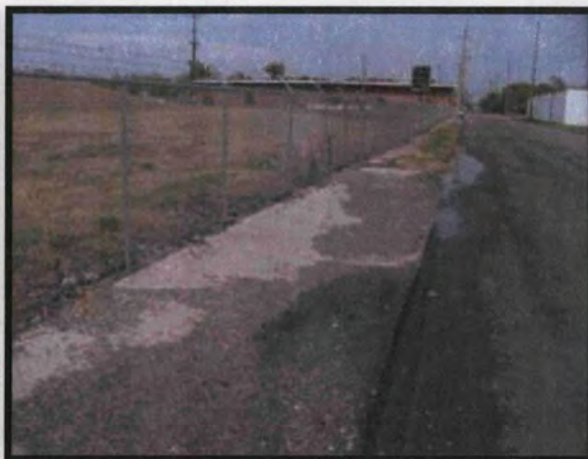
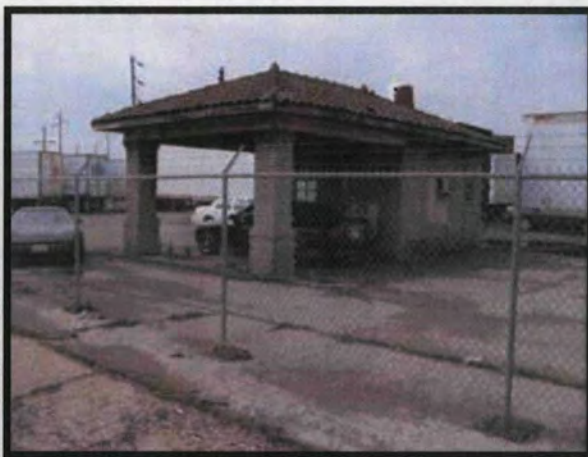
5. State Street (along the 1555 State Street property) was recently paved by the City of Granite City. The concrete sidewalk along State Street at the main industrial site is continuing to deteriorate. Some battery case chips are visible in the area below the deteriorated sidewalk.

Photograph 54: Fence, sidewalk, and vegetation along State Street.

Photograph 55: Fence, sidewalk, and vegetation along State Street.

Photograph 56: Fence, sidewalk, and vegetation along State Street.

Photograph 57: Fence, sidewalk, and vegetation along State Street.

Photograph 58: Fence, sidewalk, and vegetation along State Street.

Photograph 59: Fence, sidewalk, and vegetation along State Street.

Photograph 60: Fence, sidewalk, and vegetation along State Street.

Photograph 61: Fence, sidewalk, and vegetation along State Street.

Photograph 62: Fence and sidewalk along State Street.

Photograph 64: Fence, sidewalk, and vegetation along State Street.

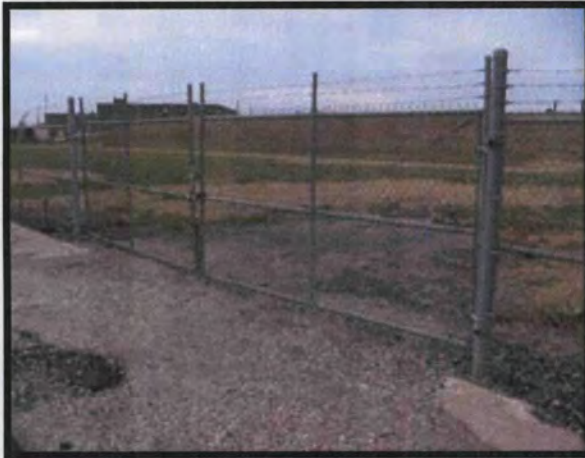
Photograph 66: Front gate (view from State Street).

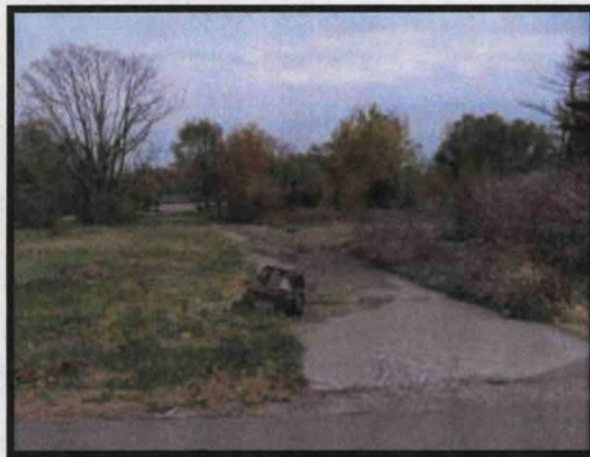
Photograph 3: 200 Harrison Street, also known as 200 Roosevelt Street (view from Harrison Street).

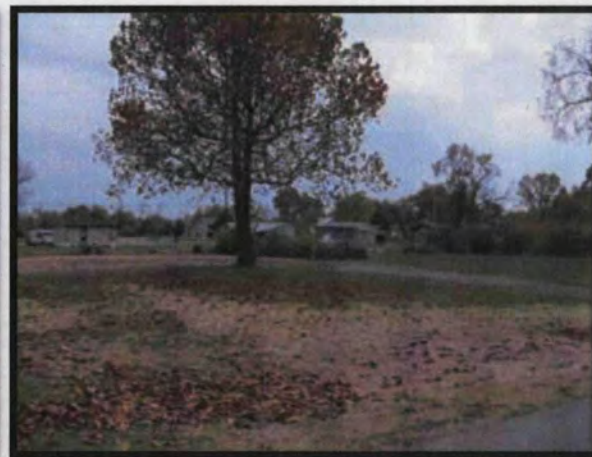
Photograph 4: 206 Terry Street (view from Terry Street).

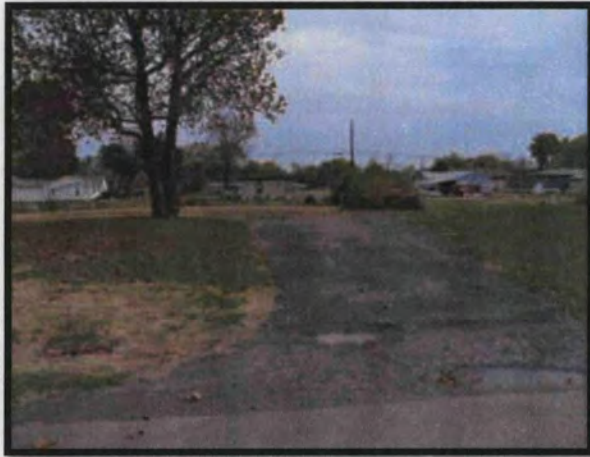
Photograph 5: 206 Terry Street (view from Terry Street).

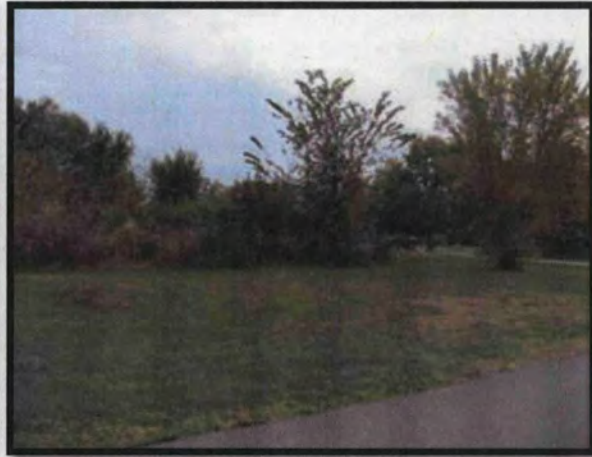
Photograph 6: 200 Allen Street (view from Terry Street).

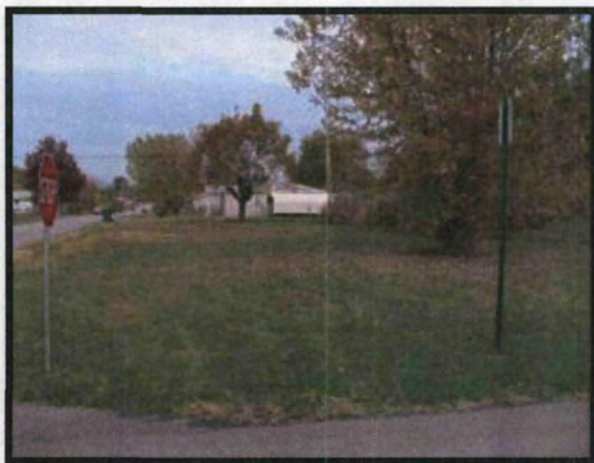
Photograph 7: 200 Allen Street (view from Allen Street).

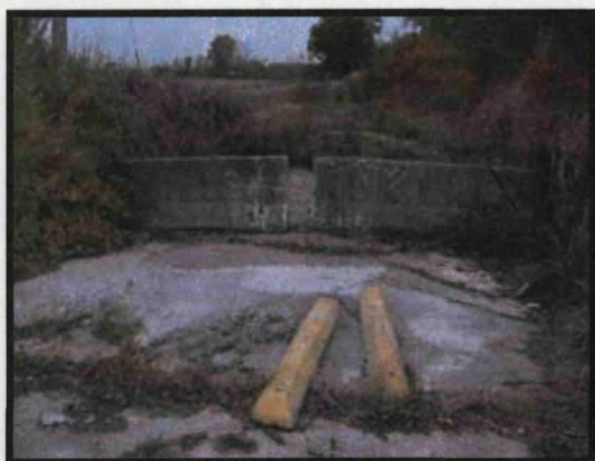
Photograph 1: Schaeffer Road property.

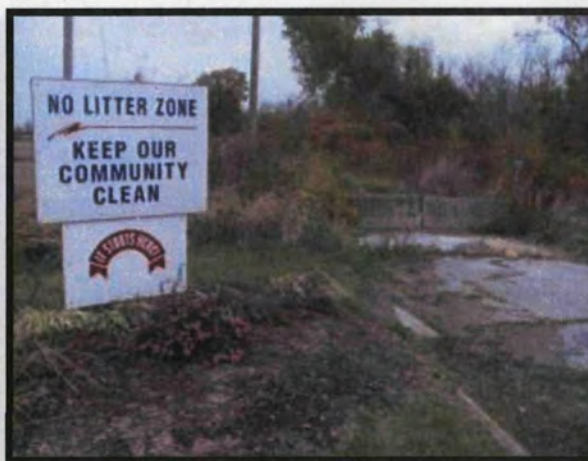
Photograph 2: Schaeffer Road property.

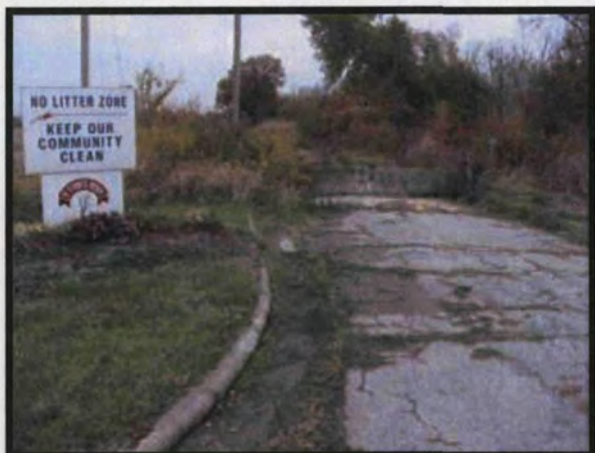
Photograph 3: Schaeffer Road property.

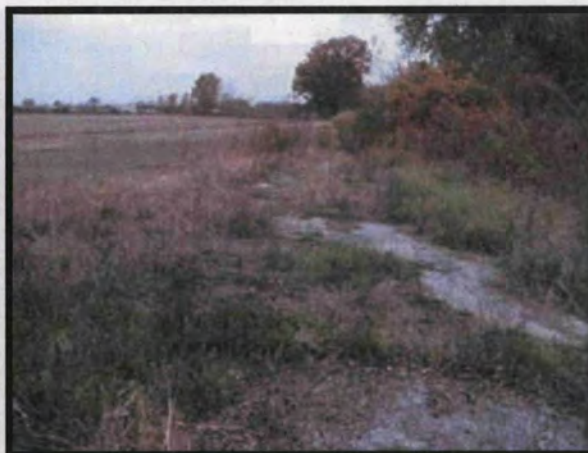
Photograph 4: Schaeffer Road property.

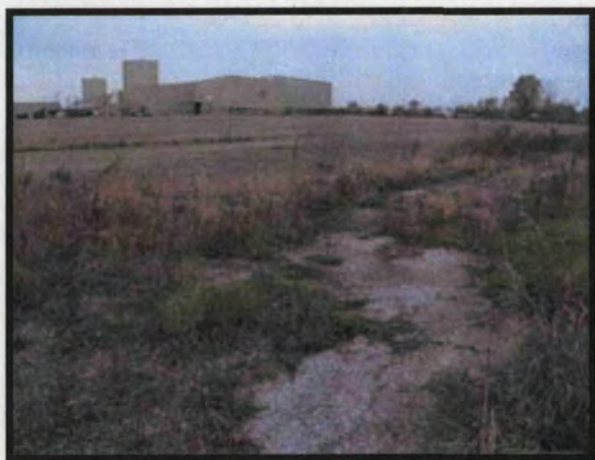
Photograph 5: Schaeffer Road property.

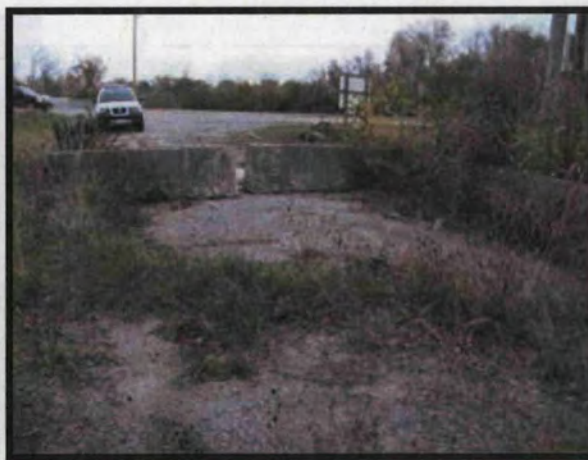
Photograph 6: Schaeffer Road property.

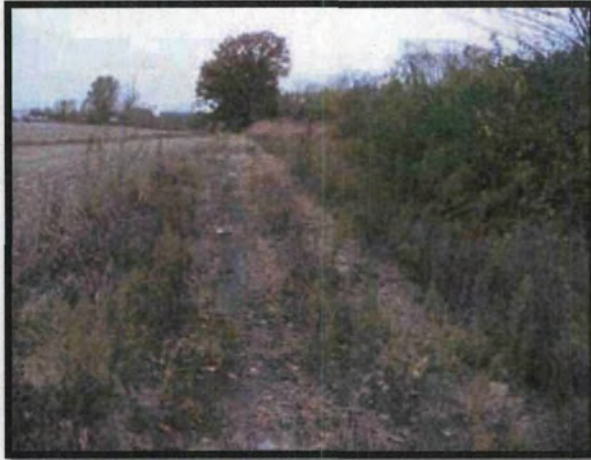
Photograph 7: Schaeffer Road property.

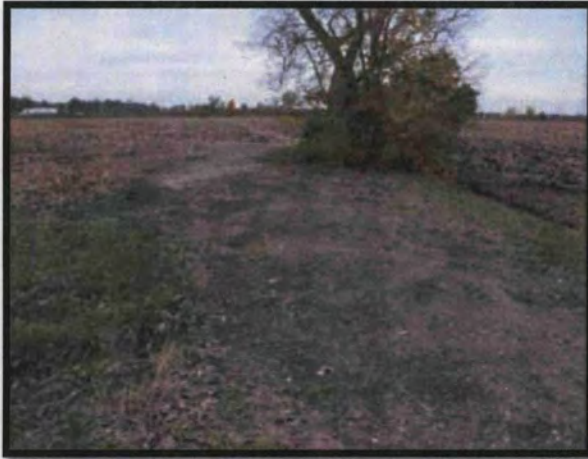
Photograph 1: Sand Road property.
